## REPAIRING SCREW OR NAIL POPS (GA-222-14)

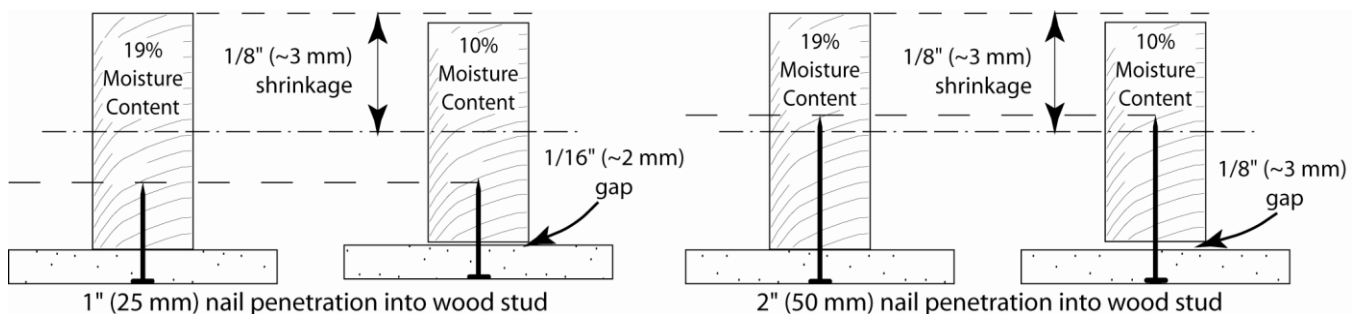
The protrusion of screw or nail heads above the gypsum panel surface is caused by one or more of the following:

- Lumber shrinkage occurring after gypsum panel product application,
- Loose attachment of the gypsum panel product to the framing,
- Improperly aligned, twisted, bent, warped, or bowed framing,
- Incorrect fastener length, or
- Improper fastening

Fastener pops are largely caused by lumber shrinkage due to initially high moisture content lumber. Overly long fastener length contributes to the problem. Use fasteners that provide the minimum recommended depth of penetration into framing members. For fire-resistance rated systems use fastener lengths specified in the listing.

Fastener pops that appear either before or during decoration should be repaired immediately. Those that appear one or more months into the heating season are usually a result of lumber shrinkage and should not be repaired until the end of the heating season.

Fastener pops are repaired by reattaching the gypsum panel product to the framing by driving a new screw or nail of the proper length into the same framing member about 1-1/2 in. (40 mm) from the popped fastener. Apply sufficient pressure to the gypsum panel to bring the back surface into firm contact with the framing member to which it is being reattached. Remove the fastener or reseal the popped fastener so that it is just below the face of the gypsum panel. Remove any loose material before treating with joint compound and redecorating.
